# Analysis of the Transverse Load Test Results from EMLA Report L-11-1869a per ICC-ES AC191-11

StructureSmith Project 120207A

Subject: Transverse Load Test on Stucco Panels

Report No.: L-11-1869a R1

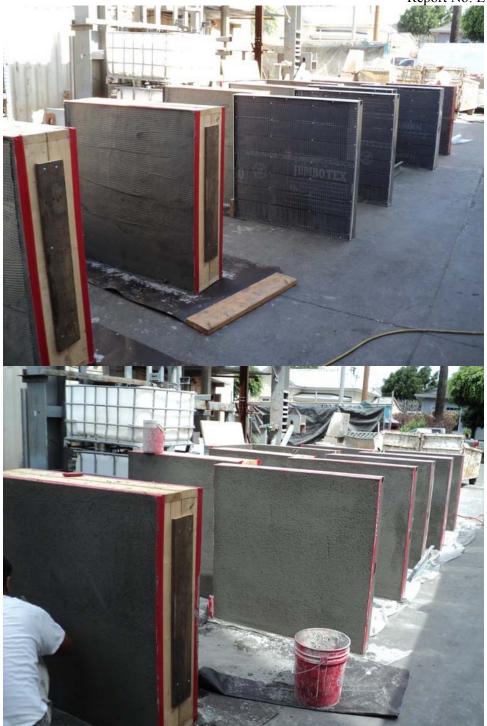
**Photo 1 – Sample Fabrication**

Eighteen stucco wall assemblies were fabricated at Smith-Emery facility by the client's contractor. The details of the panels' construction are listed in Table 1 and were verified by Smith-Emery representatives. All samples were 4-feet long by 4-feet wide and constructed with the frames standing vertically. The scratch coat was applied on 9/21/11, the brown coast was applied on 9/23/11, and the finish coat was applied on 9/30/11.

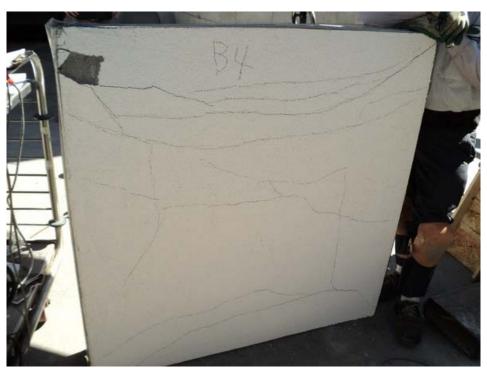
**Photo 3 – Typical Failure (B4)**

Loading Type	Sample ID	Test Date	Maximum Load (psf)	Average Load (psf)	Failure Mode*
	A1	10/6/11	258		2
	A2	10/6/11	273	262	2
	A3	10/7/11	254		2
	B1	10/11/11	544		1
Positive	B2	10/12/11	590	564	1
	В3	10/12/11	557		1
	C1	10/7/11	302		3, 5
	C2	10/10/11	380	332	3, 5
	C3	10/10/11	315		3, 5
	A4	10/6/11	145		2
	A5	10/6/11	142	149	2
	A6	10/7/11	159		2
	B4	10/11/11	369		5
Negative	B5	10/12/11	398	396	5
	В6	10/12/11	421		5
	C4	10/7/11	167		4
	C5	10/10/11	148	157	4
	C6	10/10/11	156		4

- \* Failure mode:
- 1. No failure:
- 2. Global flexural failure at the mid-span of the panel;
- 3. Frame members connection failure;
- 4. Metal lath pulling through fasteners;
- 5. Stucco panel crack;

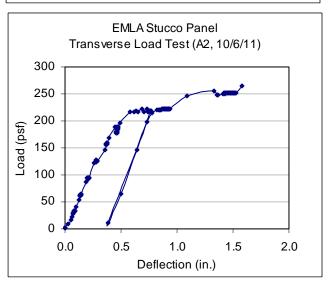
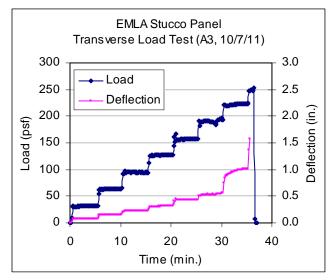
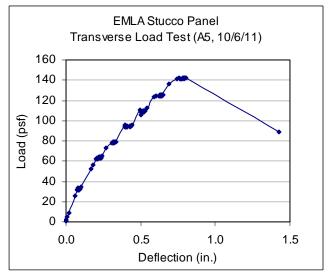
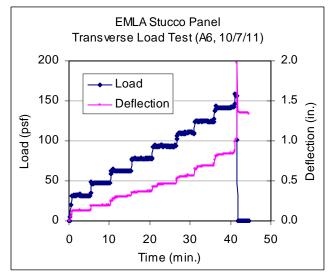
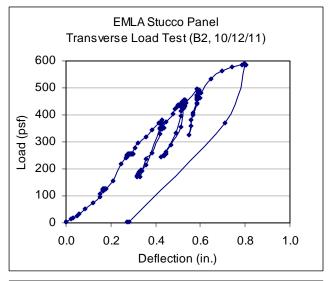
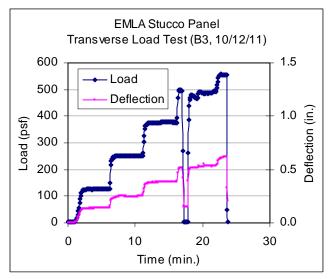
#### **LOAD- DEFORMATION CHARTS**

Eighteen stucco wall panels were tested for transverse loading. The results are summarized in Table 3. The load-deformation charts are included in Appendix B.
