Subject: Transverse Load Test on Stucco Panels

At your request, transverse load tests were performed on 18 stucco wall assemblies with 3.4 self-furring expanded metal lath in October, 2011 in general accordance with ICC-ES AC191, *Acceptance Criteria for Metal Plaster Bases (Lath)*, effective June, 2009. The attached Report Number L-11-1869b R1 presents the description of the tests performed, the results of our testing, and our findings.

**SUBJECT REPORT: TRANSVERSE LOAD TEST ON STUCCO PANELS**

**Report No.:** L-11-1869b R1

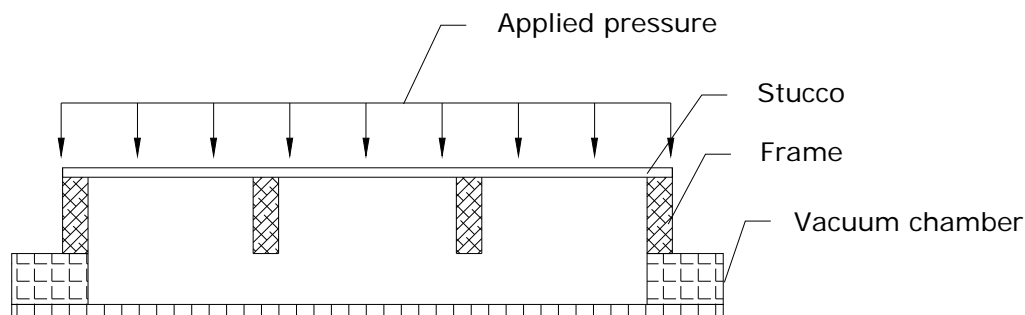
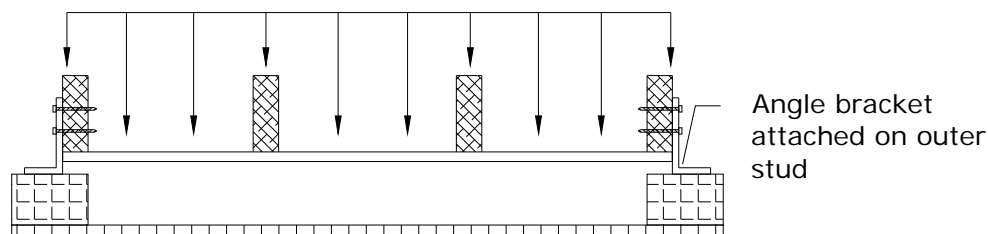
**Figure 1 – Test Setup**

Each specimen was subjected to either a positive or negative uniform pressure until failure. The sample was installed horizontally on a vacuum chamber. For a positive pressure test, the sample was placed with the stucco panel facing up and supported continuously under the two outer studs. For a negative pressure test, the sample was installed with the stucco panel facing down. To avoid direct support under the stucco, angle brackets were used to attach the two outer studs. Refer to Figure 1 for clarification.

Positive pressure Test

Negative Pressure Test

A plastic sheet (2 mils) was used to cover the top of panel and sealed the chamber. A vacuum pump was used to generate partial vacuum inside the chamber so the plastic sheet will apply a uniform pressure on the whole panel. The loading process was controlled manually.

A differential pressure transducer was used to measure the relative pressure across the chamber. The deflections of each panel were measured at the center of the stucco panel by one displacement transducer.

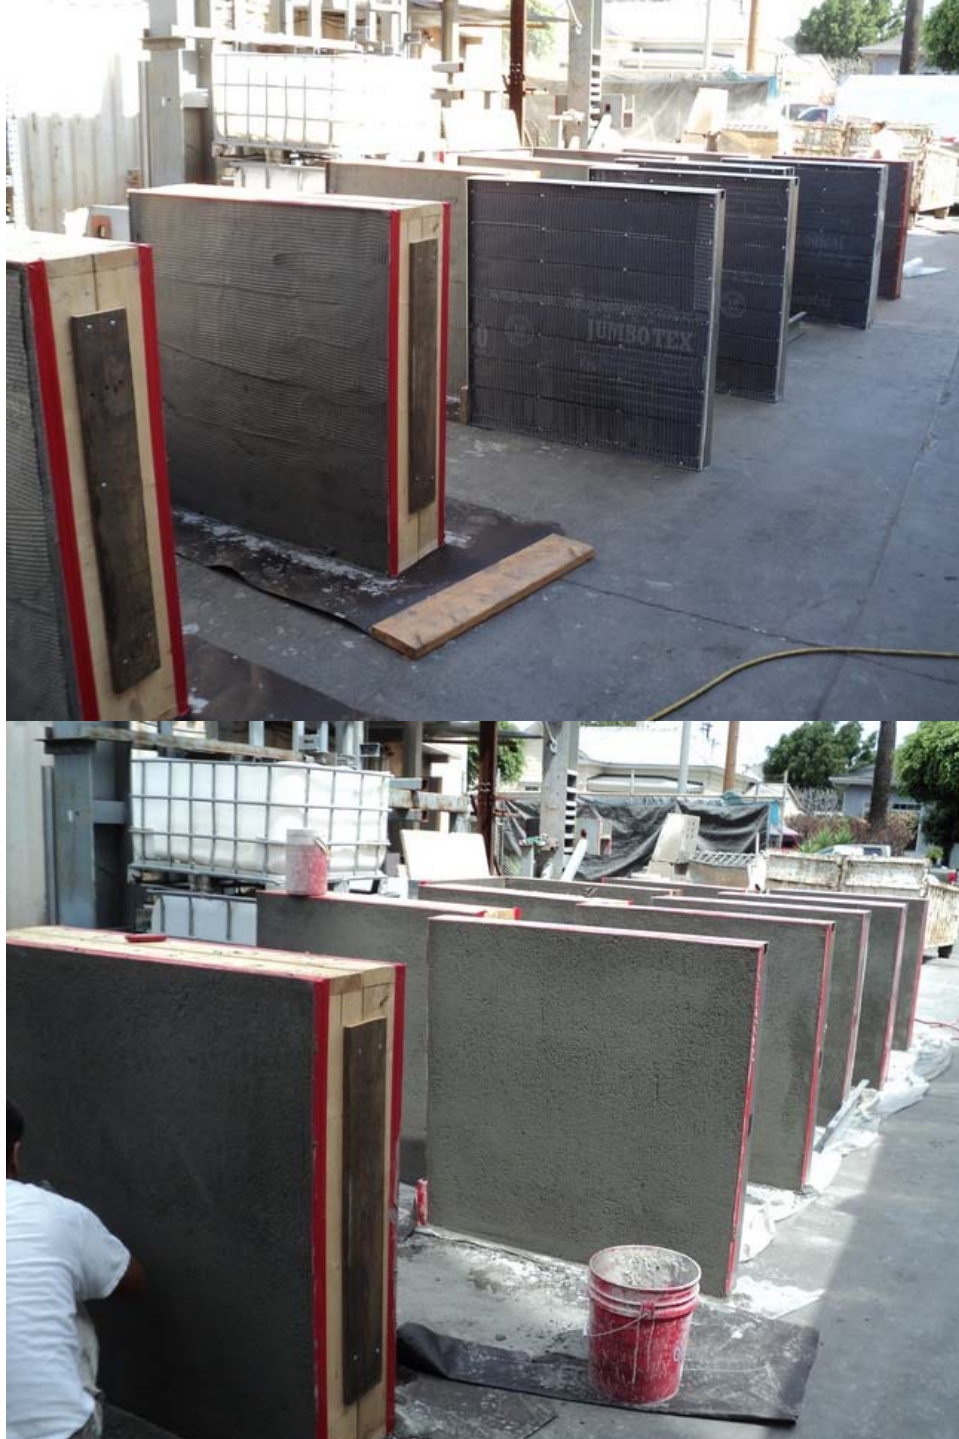
**Photo 1 – Sample Fabrication**

Eighteen stucco wall assemblies were fabricated at Smith-Emery facility by the client's contractor. The details of the panels' construction are listed in Table 1 and were verified by Smith-Emery representatives. All samples were 4-feet long by 4-feet wide and constructed with the frames standing vertically. The scratch coat was applied on 9/21/11, the brown coat was applied on 9/23/11, and the finish coat was applied on 9/30/11.

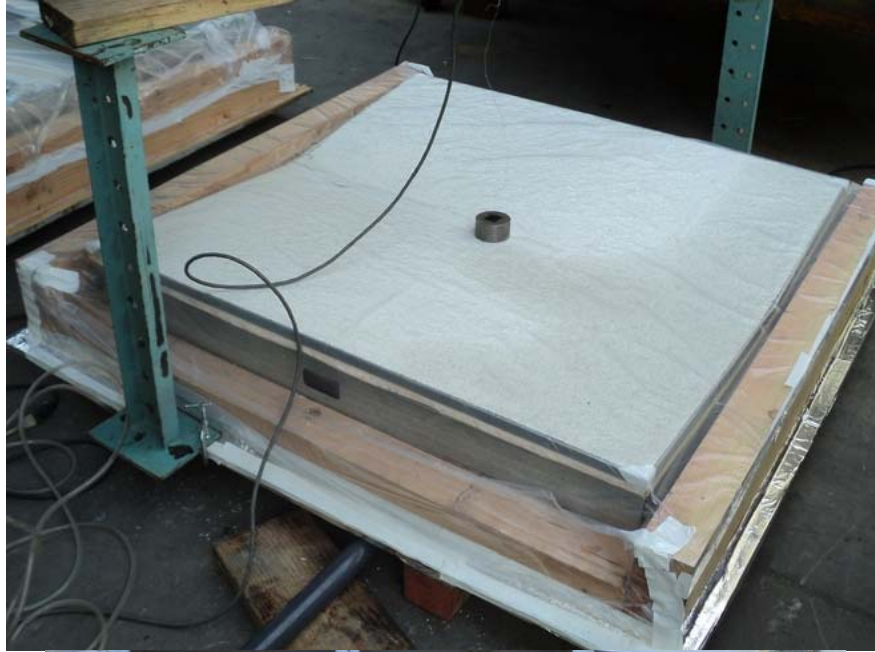
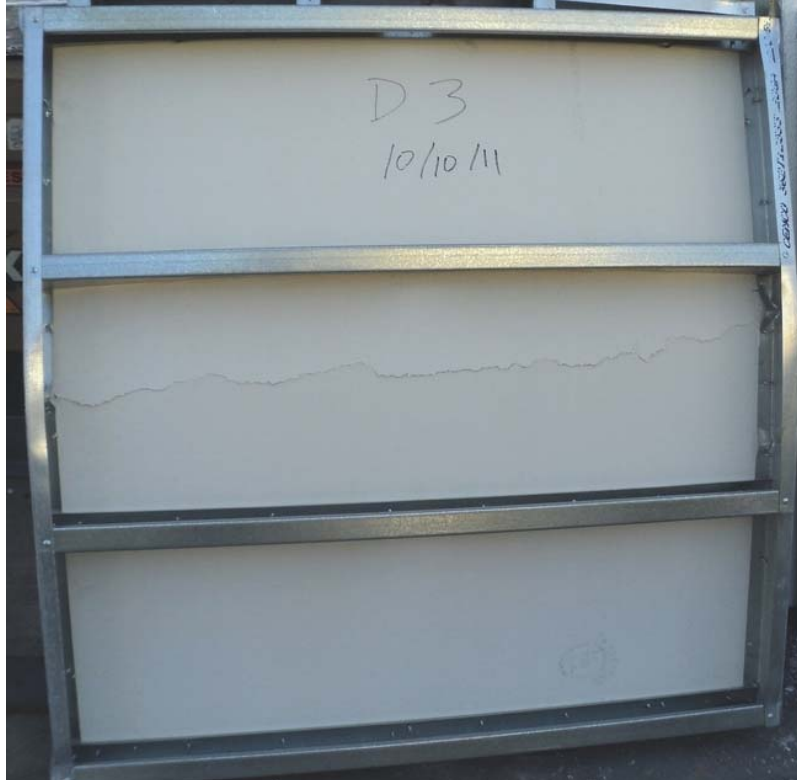
**Photo 3 – Typical Failure (D3)**

| Loading Type | Sample ID | Test Date | Maximum Load (psf) | Average Load (psf) | Failure Mode* |
|---|---|---|---|---|---|
| | D3 | 10/10/11 | 314 | | 2 |

1. No failure;
2. Global flexural failure at the mid-span of the panel;
3. Frame members connection failure;
4. Metal lath pulling through fasteners;
5. Stucco panel crack;

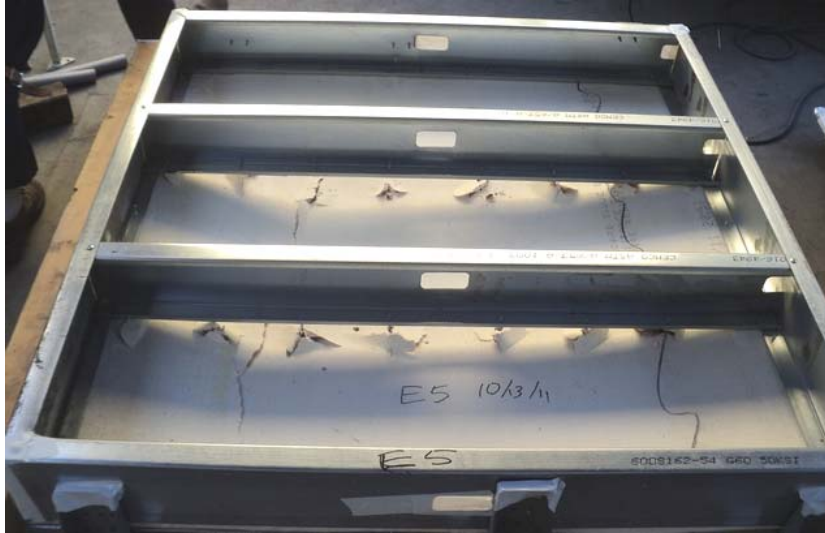
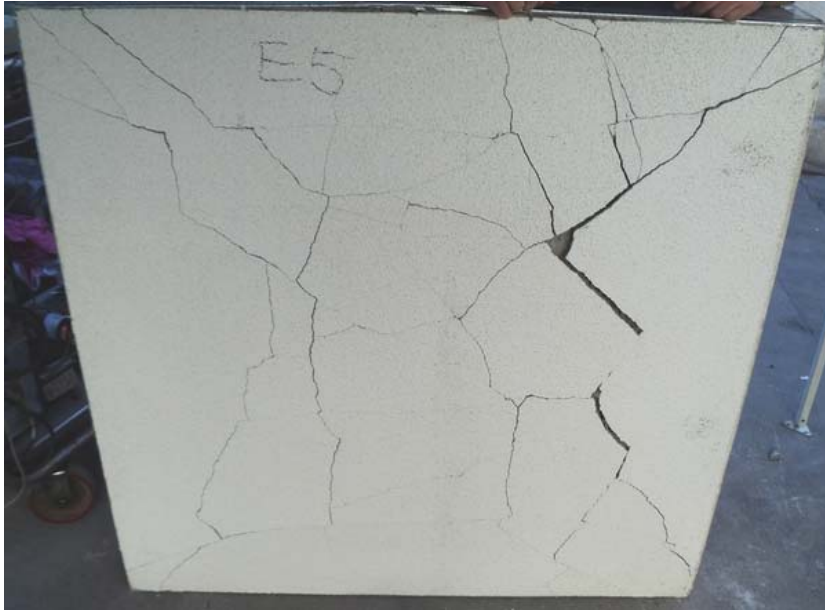
**Photo 4 – Typical Failure (E5)**

| Loading Type | Sample ID | Test Date | Maximum Load (psf) | Average Load (psf) | Failure Mode* |
|---|---|---|---|---|---|
| | E5 | 10/13/11 | 313 | | 4, 5 |

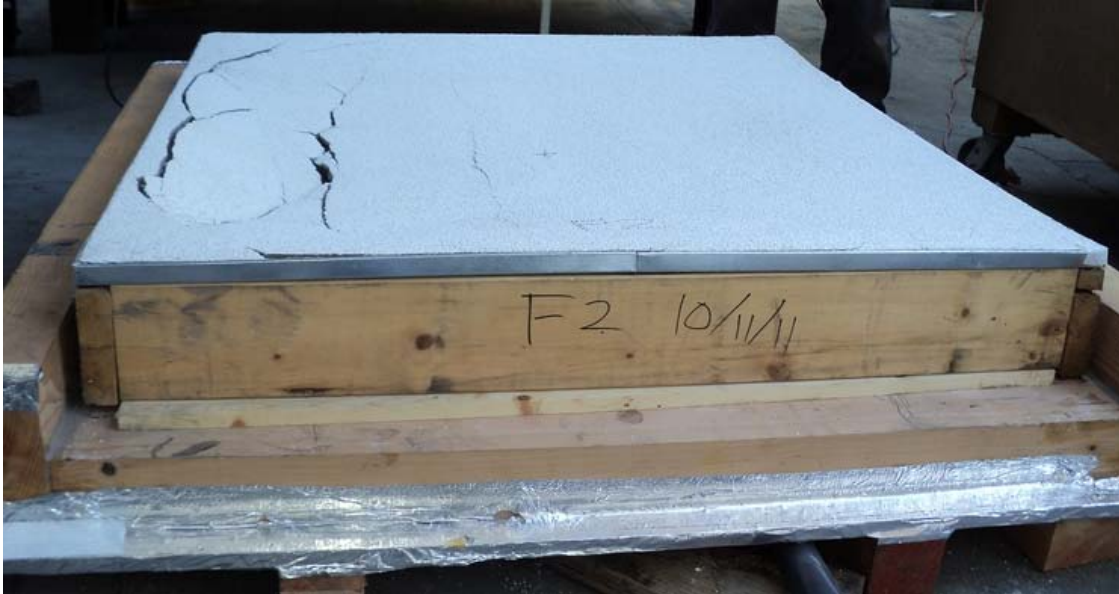
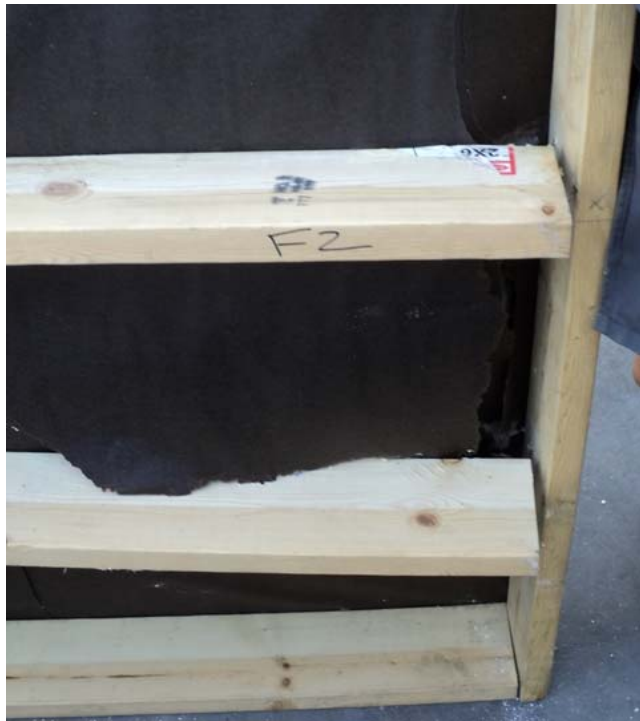
**Photo 5 – Typical Failure (F2)**

| Loading Type | Sample ID | Test Date | Maximum Load (psf) | Average Load (psf) | Failure Mode* |
|---|---|---|---|---|---|
| | F2 | 10/11/11 | 378 | | 3, 5 |

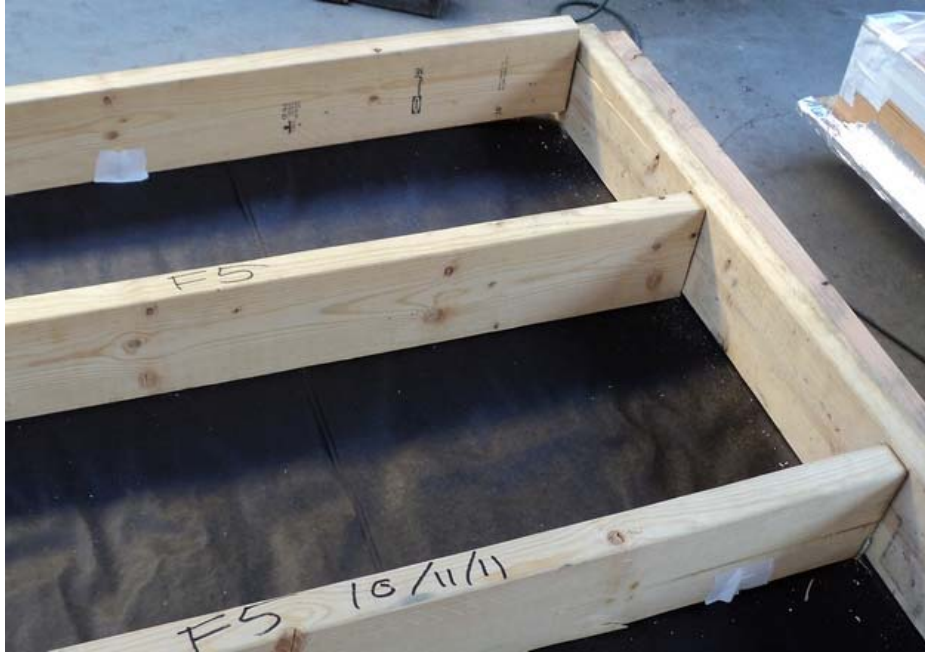
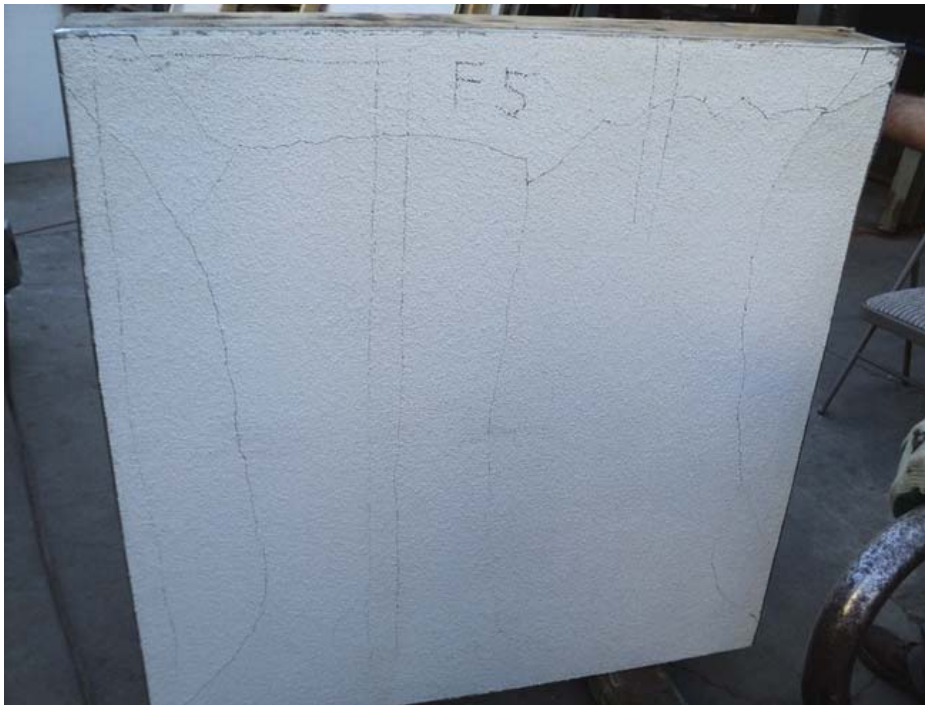
**Photo 6 – Typical Failure (F5)**

| Loading Type | Sample ID | Test Date | Maximum Load (psf) | Average Load (psf) | Failure Mode* |
|---|---|---|---|---|---|
| | F5 | 10/11/11 | 247 | | 3, 5 |
