Project No.: 40205-1

Subject: Transverse Load Test on Stucco Panels

SUBJECT REPORT: TRANSVERSE LOAD TEST ON STUCCO PANELS

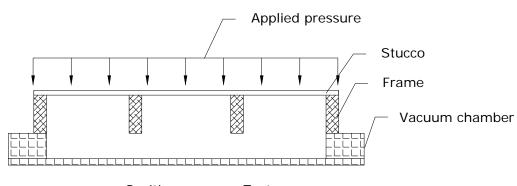
Figure 1 – Test Setup

Positive pressure Test

Negative Pressure Test

Each specimen was subjected to either a positive or negative uniform pressure until failure. The sample was installed horizontally on a vacuum chamber. For a positive pressure test, the sample was placed with the stucco panel facing up and supported continuously under the two outer studs. For a negative pressure test, the sample was installed with the stucco panel facing down. To avoid direct support under the stucco, angle brackets were used to attach the two outer studs. Refer to Figure 1 for clarification.
